RM No. E8F29

# RESEARCH MEMORANDUM

OPERATING TEMPERATURES OF I-40-5 TURBOJET ENGINE  
BURNER LINERS AND THE EFFECT OF TEMPERATURE  
VARIATION ON BURNER-LINER SERVICE LIFE

By H. D. Wilsted, Robert T. Duffy  
and Ralph E. Grey

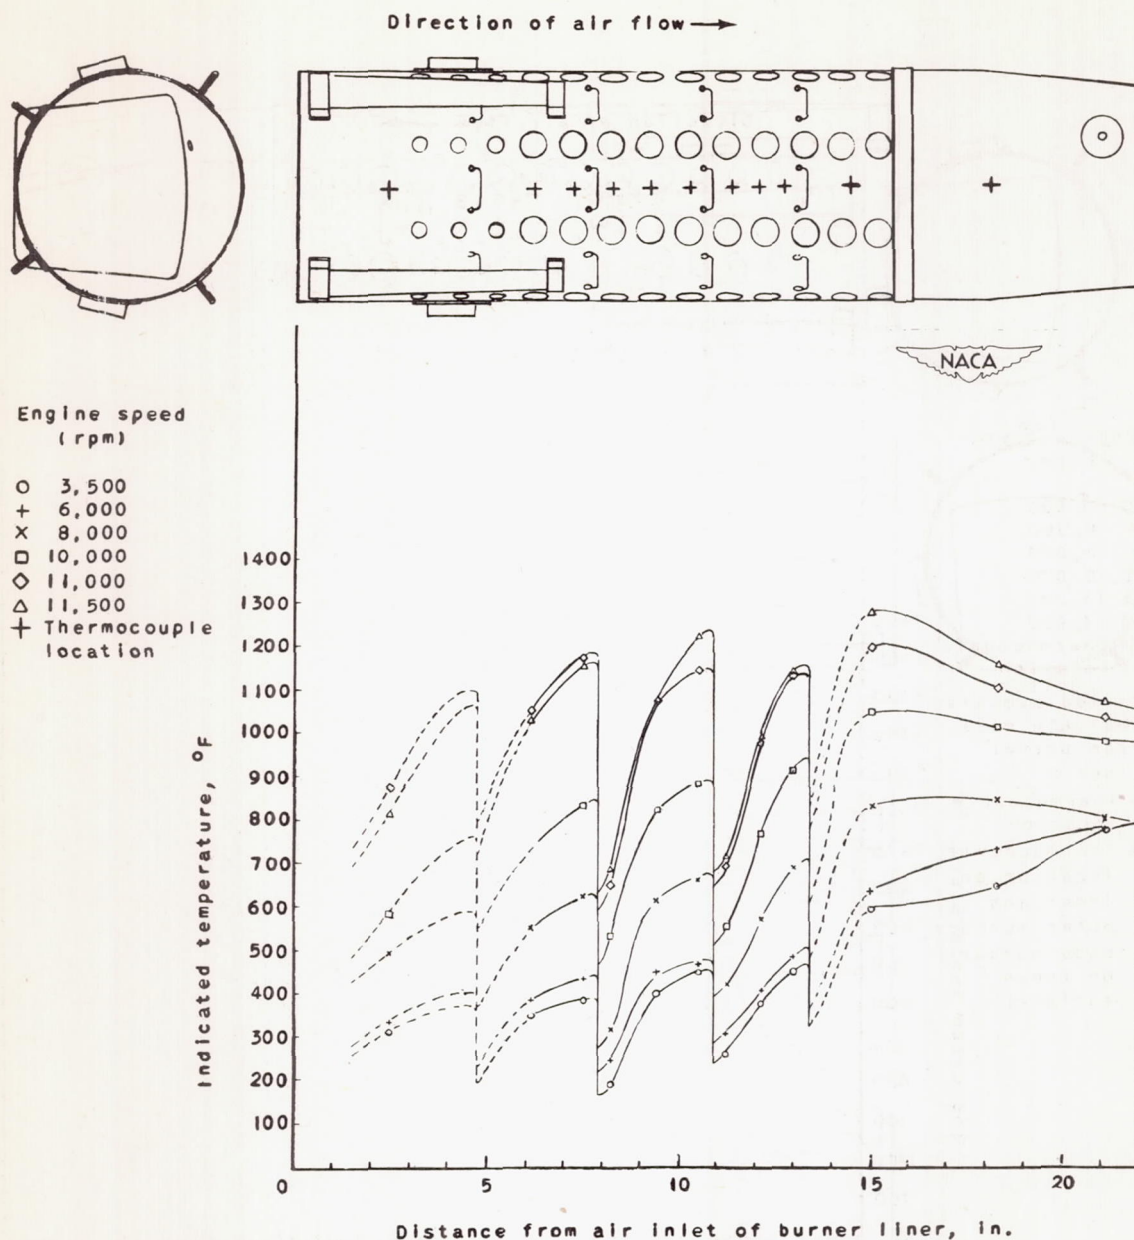
The thermocouple locations on the first burner liner investigated (designated liner A) are shown in figure 6. The results of the investigations of liner A over a complete range of engine speed are shown in figures 7, 8, and 9. Figure 7 shows the temperature variation along the top row of cooling louvers. At maximum engine speed a variation of the order of 600° F in a length of 3 inches is shown. The maximum indicated temperature along the row of louvers is of the order of 1300° F.

Figure 7. - Temperature variation along top row of cooling louvers on burner liner A at various engine speeds.

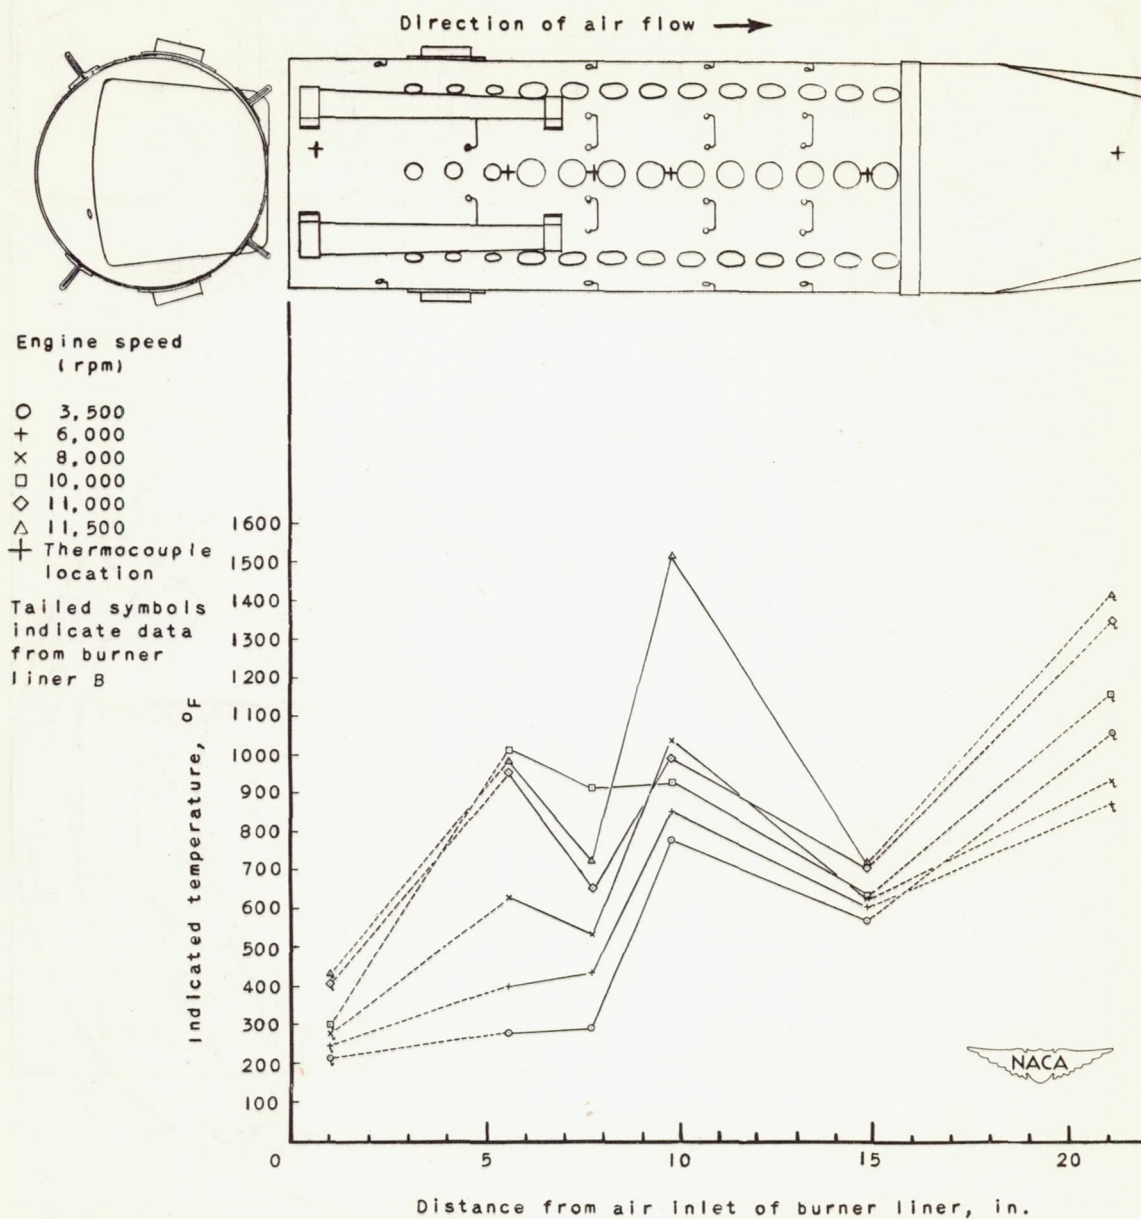
The temperature variation along the center line of a section containing air-intake holes is shown in figure 8. This section is on the bottom of the liner, as shown in figure 6. With one exception, the maximum indicated temperature was only of the order of 1000° F if the noncritical liner-exit section is not considered. As can be seen from figure 9, these values are probably peculiar to the particular sections and no general conclusions comparing the louver and air-intake sections can be drawn. The wide circumferential temperature variations shown in figure 9 indicate no definite trend. An irregularity exists, however, in the pattern with the highest temperature region located at the lowest portion of the burner liner as installed in burner 12.

Figure 8. - Temperature variation along bottom row of air intake holes on burner liner A at various engine speeds.

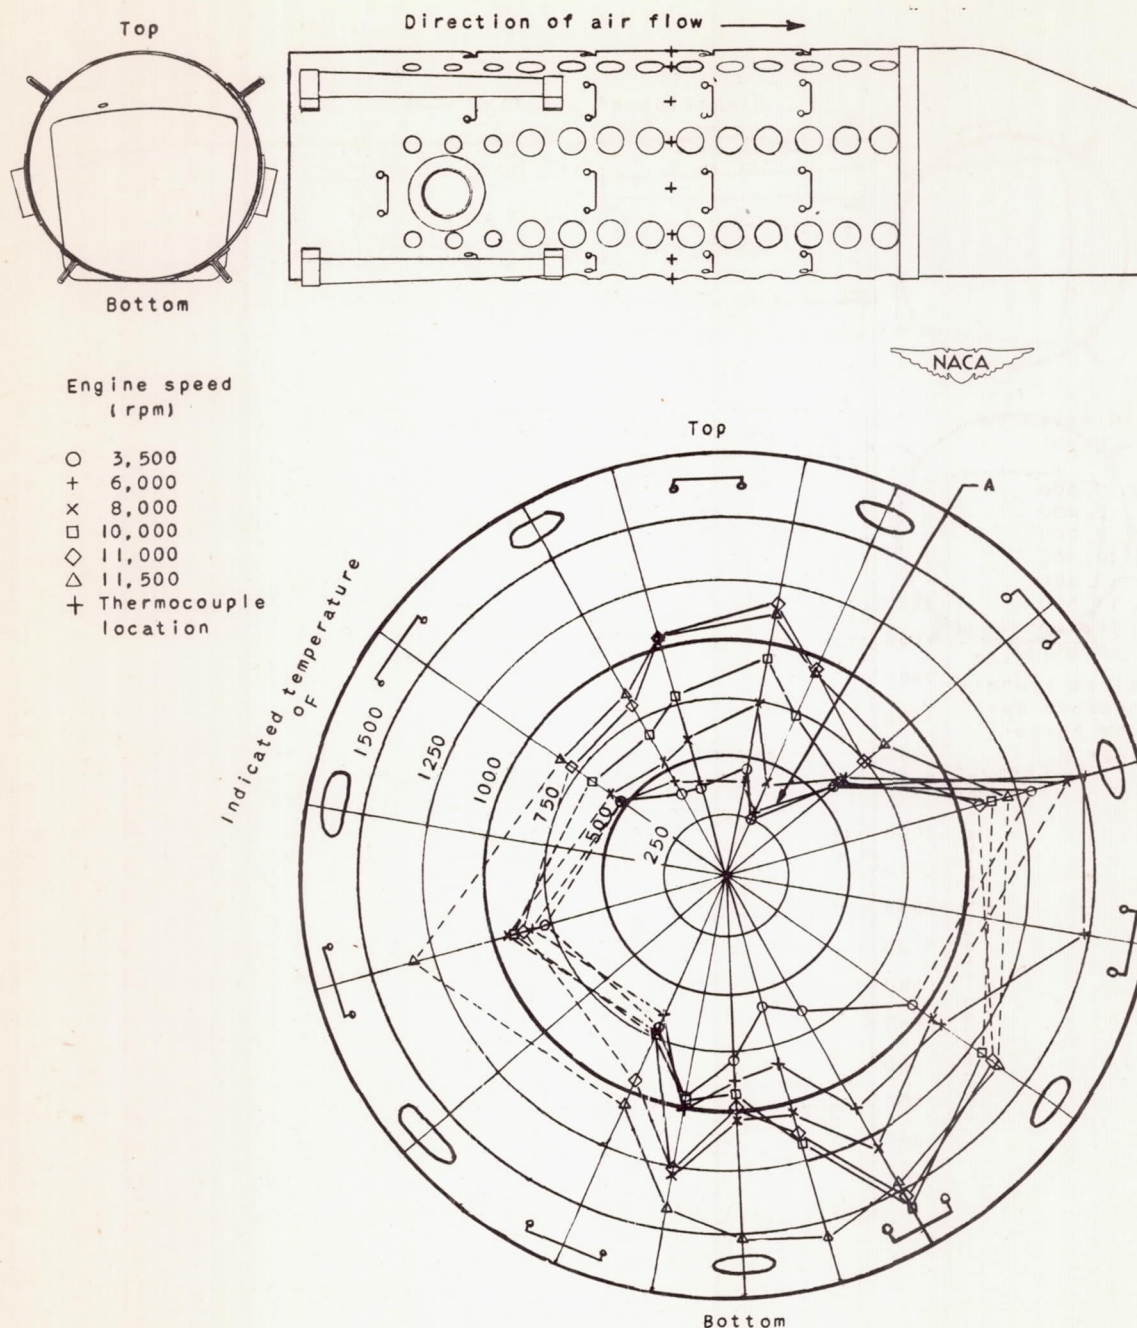
sections containing the louvers and air-intake holes, respectively. An examination of the data shows that the highest indicated burner-liner temperature recorded in these investigations was 1590° F, as shown in figure 9 at an engine speed of 11,500 rpm. This peak temperature occurred in the thermocouple belt  $9\frac{1}{2}$  inches from the inlet end of the liner near the critical section.

Temperature gradients as great as 700° F per inch of circumference are shown in figure 9 (point A). The high-temperature gradients from point to point in the burner liner are probably the cause of failure, the principal factor at the present time limiting the service life of the gas-turbine engine. Any process or method that will remove heat from the hot spots or give a more even temperature distribution such as the use of heavier gage metal for the liners to more rapidly conduct heat away from the hot spots or the use of cooling fins to remove heat from the high temperature areas should add materially to the burner-liner service life.

Figure 9. - Circumferential burner-liner temperature distribution near hottest temperature belt on burner liner A at various engine speeds. Average diameter of liner, 5.5 inches. (Dashed lines indicate missing temperature readings as a result of thermocouple failure.)

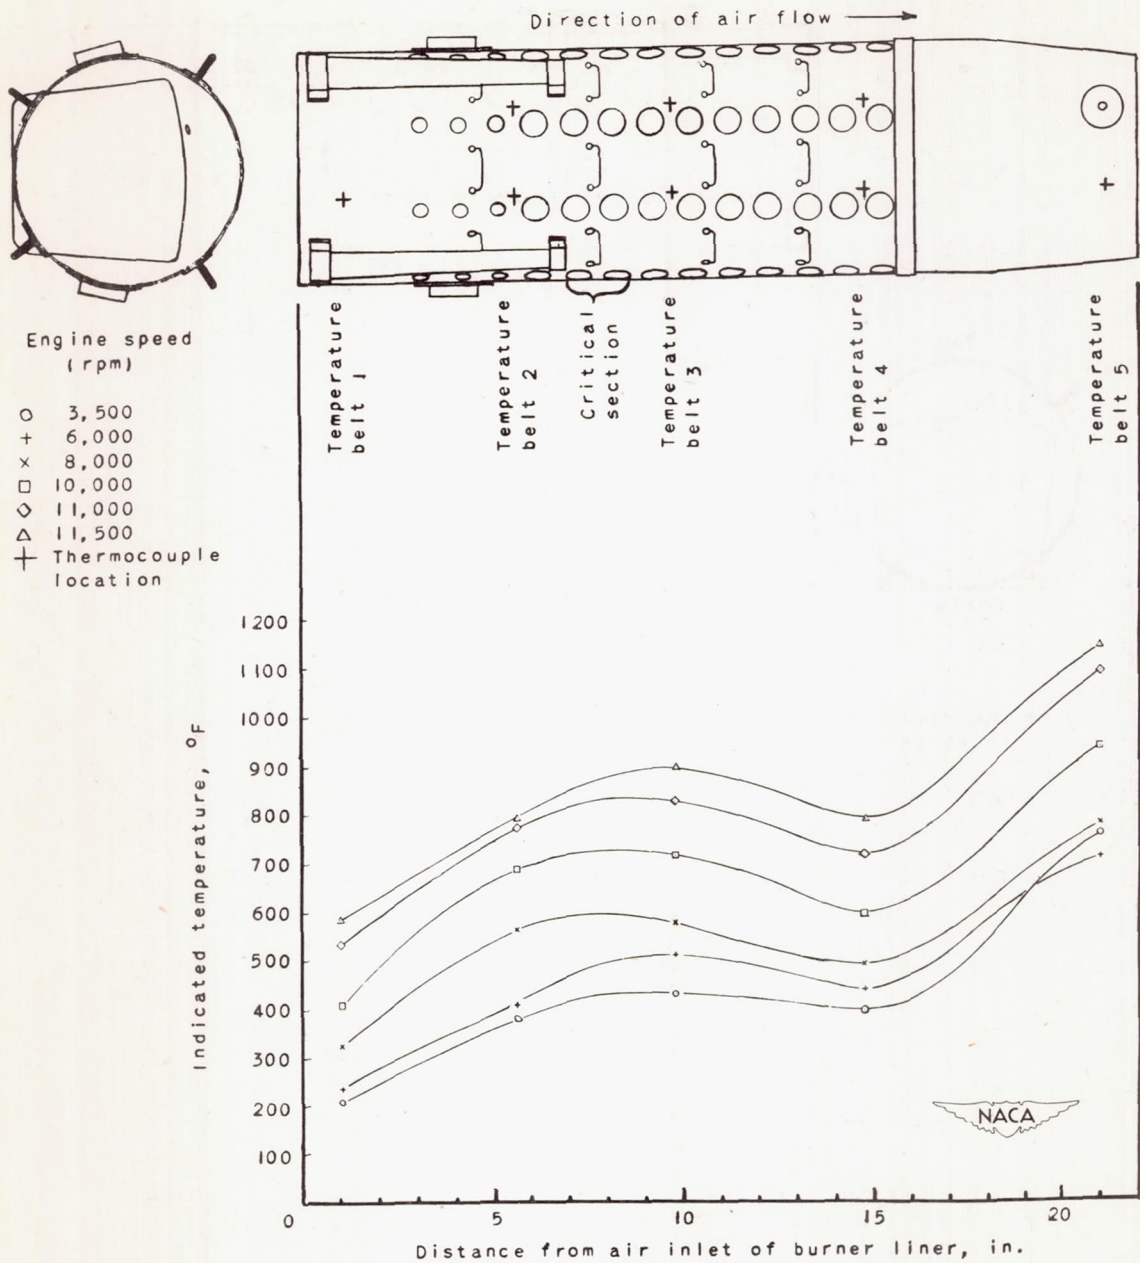
figure 11. The average values show the following trend: a peak in temperature about one-third the length downstream on the liner with a greater peak occurring at the liner exit. It is in the region of the first-mentioned peak temperature that liners have failed in NACA investigations. These failures occur in the form of fractures and severe warping extending from the louvers to the air-intake holes at a section approximately 8 inches from the inlet end of the liner. This failure belt will hereinafter be referred to as the "critical section." Inspection of service liners has also shown failures at other locations between air-intake holes and louvers but in every case of this type there was a more serious failure at the critical section.

Figure 11. - Temperature variation along length of burner liner B. All points are average of belt temperatures.

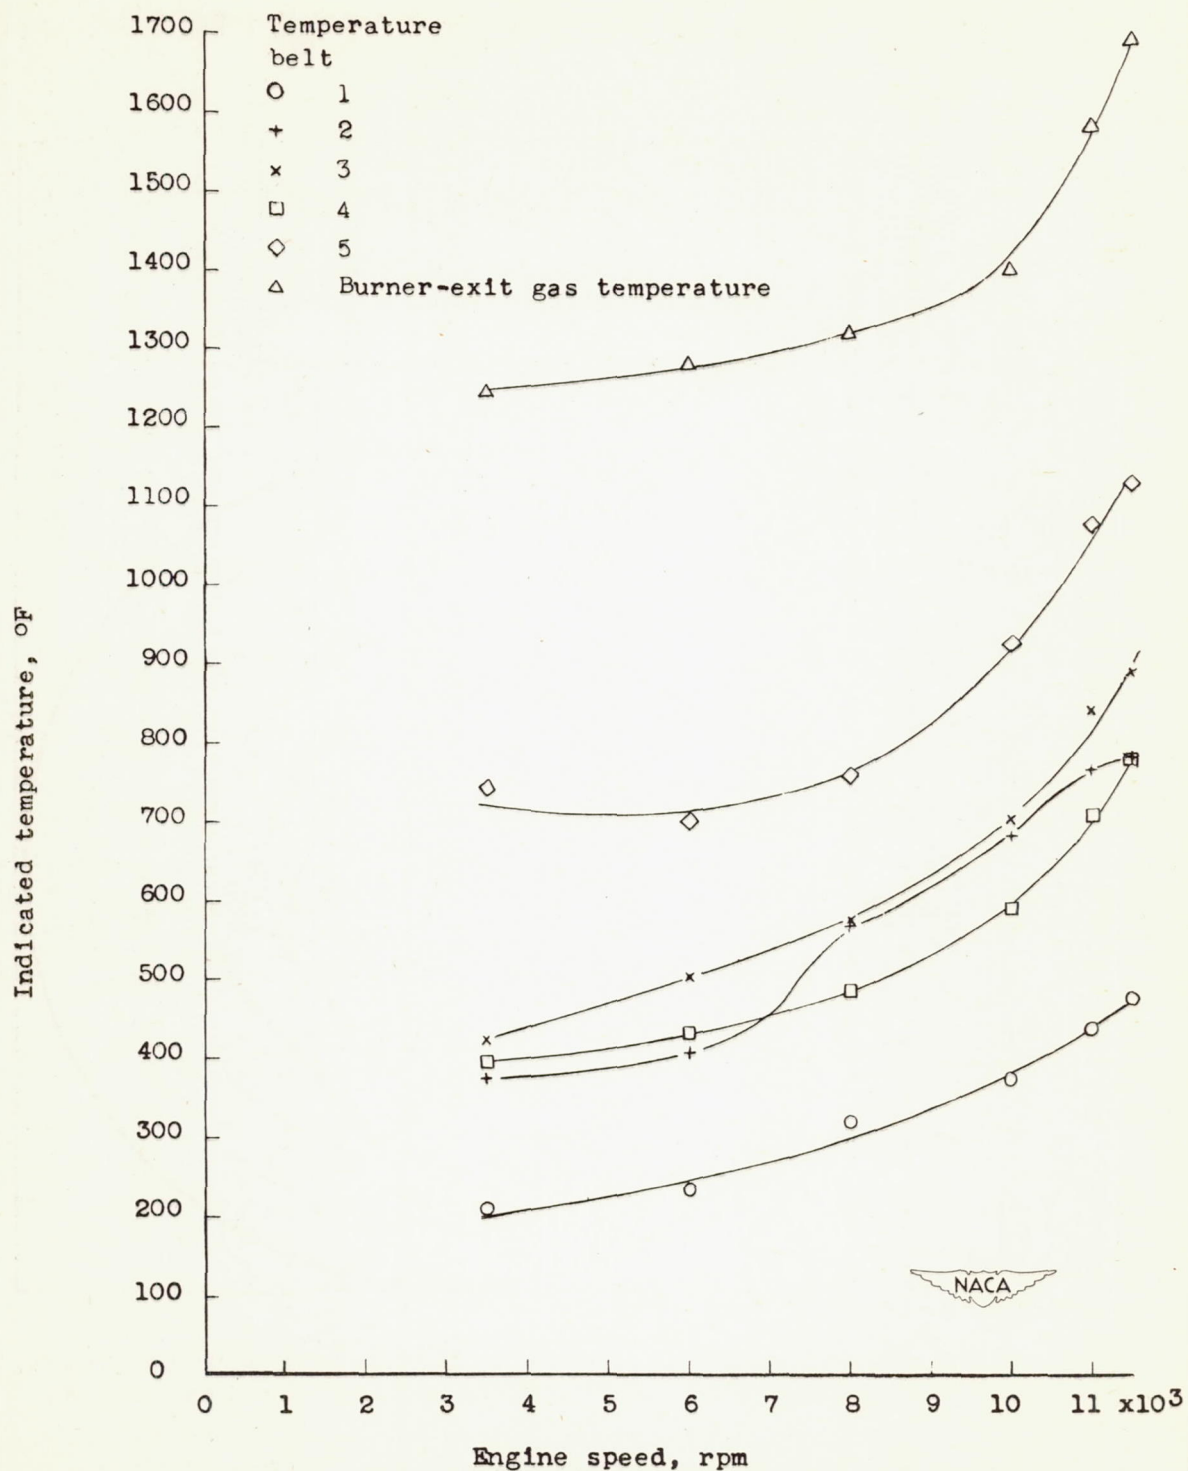
A replot of the data used in figure 11 is presented for each temperature belt in figure 12 to show the temperature variations with speed. The trend of rising burner-liner temperature with increasing speed or power in figure 12 is reasonably uniform. The irregularity of temperature belt 2 is attributed to the disturbance of the interconnector fittings on air flow. Also shown is the indicated burner-exit gas temperature, which reached a maximum of 1690° F at an engine speed of 11,500 rpm. In general, all the curves are reasonably smooth with temperatures rising at an increasing rate with engine speed.

Figure 12.- Temperature variation with engine speed of temperature belts on burner liner B. All points are average belt temperatures. (See fig. 11 for belt location.)

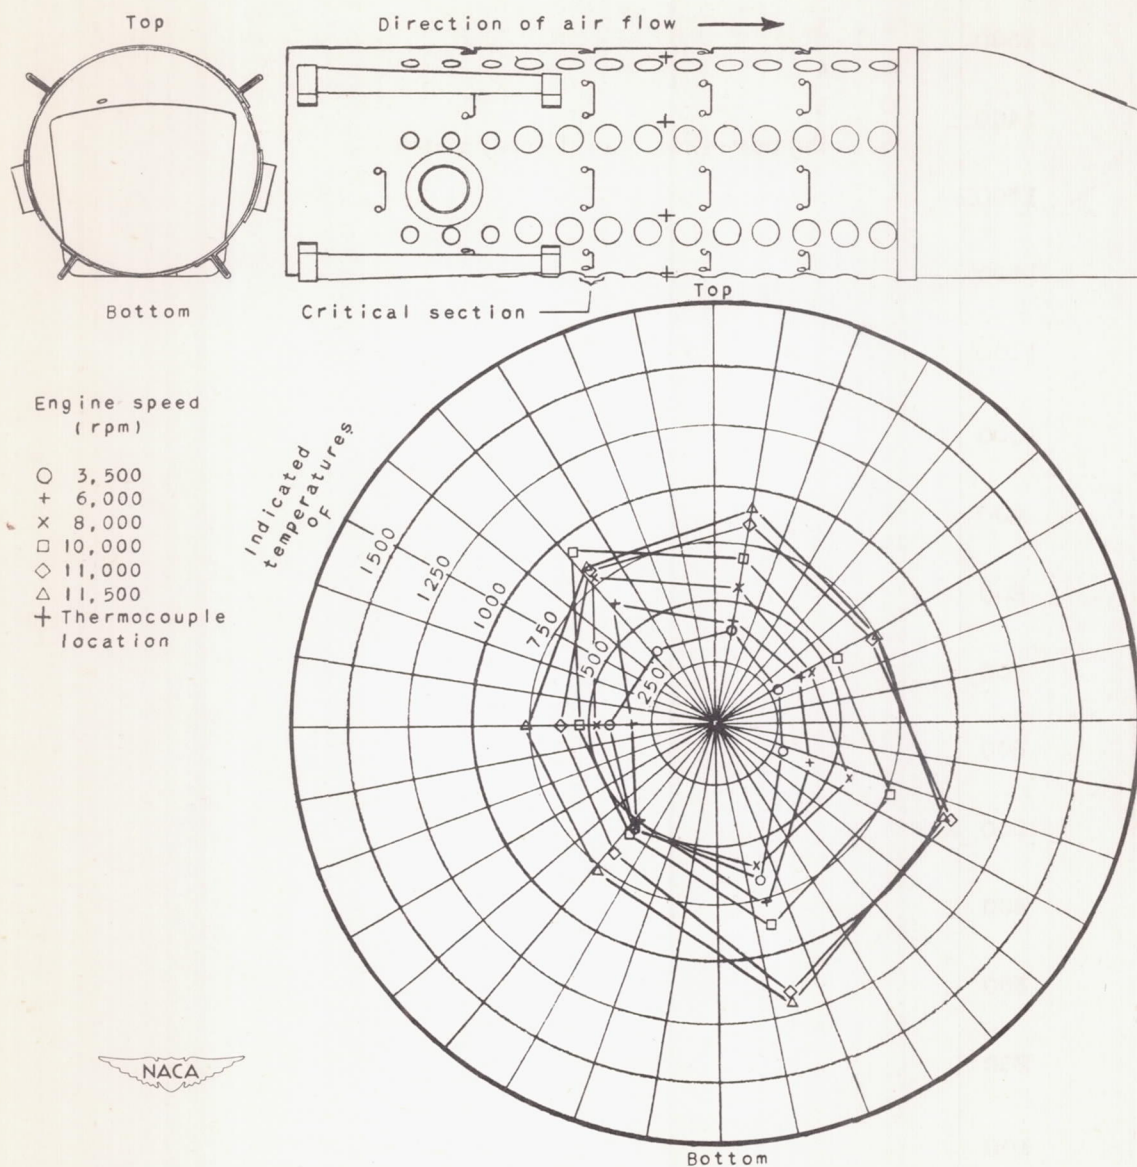
The circumferential temperature variation nearest the critical section is presented in figure 13. An appreciable temperature variation occurs with a decidedly high-temperature region located at the lowest portion of the burner liner as installed in burner 12. This peak agrees with that of figure 9. The high-temperature region is behind the right-hand interconnector fitting. The axial temperature distribution along this section is shown in figure 14 and the temperature behind the left-hand interconnector fitting in figure 15. These figures also show the maldistribution indicated in figure 13. The peak temperatures behind the right-hand interconnector fitting at the higher speeds are of the order of 500° F greater than the corresponding section behind the left-hand interconnector fitting. Inasmuch as air-flow patterns approaching the burner have not yet been obtained, it is not known whether this shift is a result of air-flow variations or maldistribution of fuel.

Figure 13. - Circumferential temperature distribution near-critical section of burner liner B at various engine speeds.

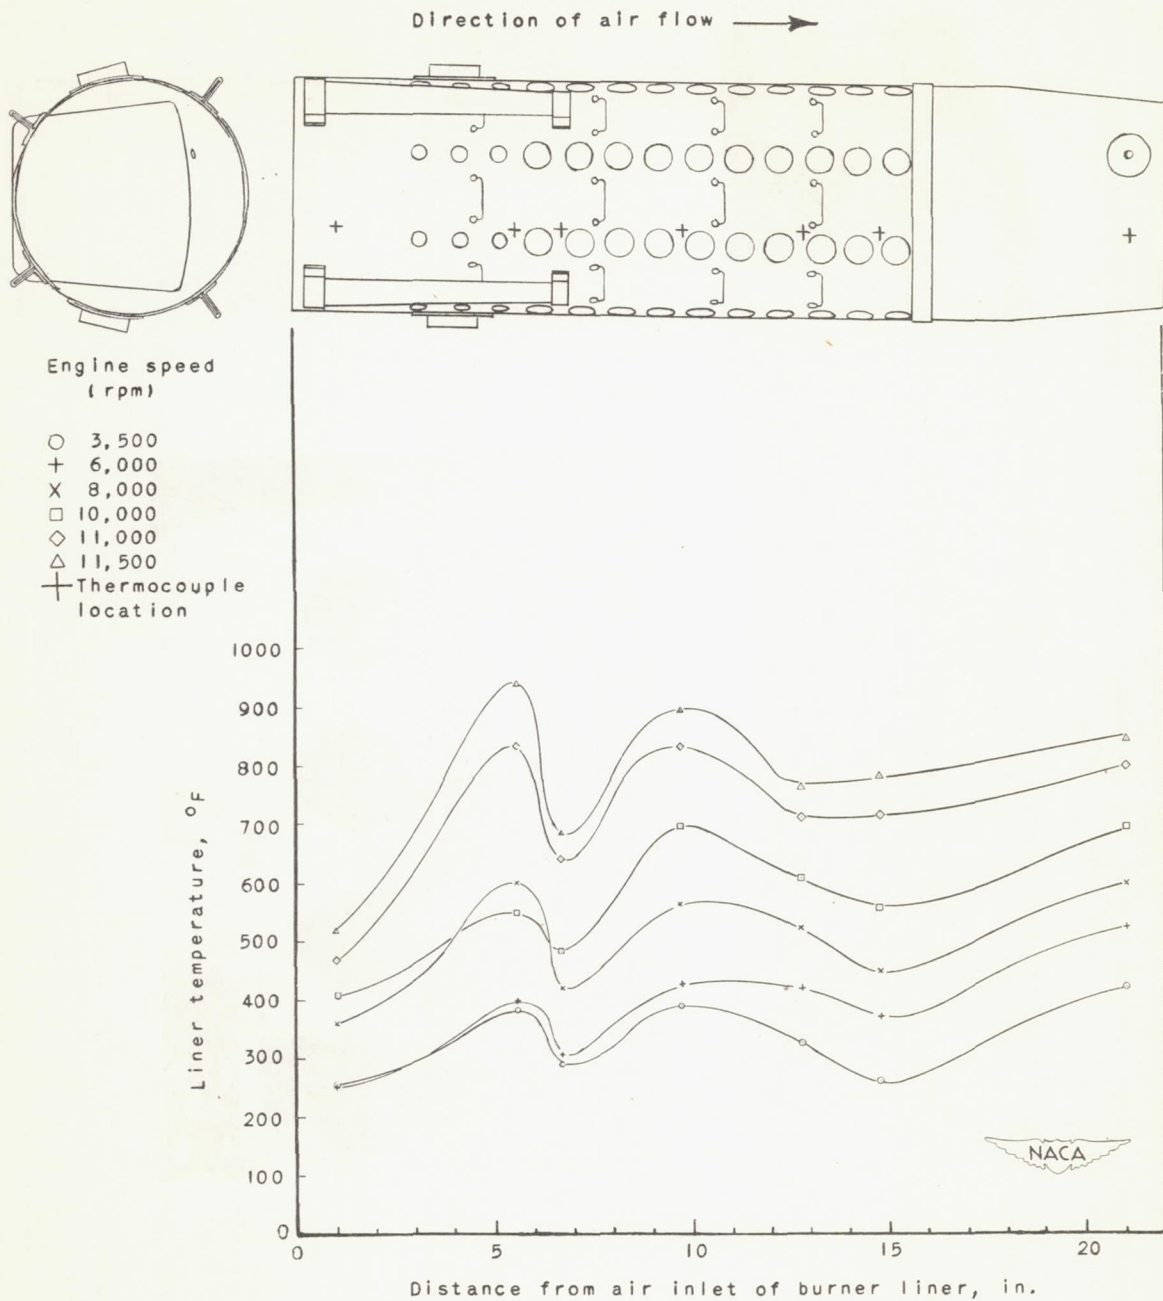
The temperature variations along the top of burner liner B, between the louvers and air-intake holes, are shown in figure 16. Except for the rapid variation in temperature at the section between the series of small and large air-intake holes, a relatively small temperature variation exists as contrasted by the variations in figures 7 and 8 for the axial distribution along the center line of the

Figure 16. - Temperature variation along top of burner liner B at various engine speeds.

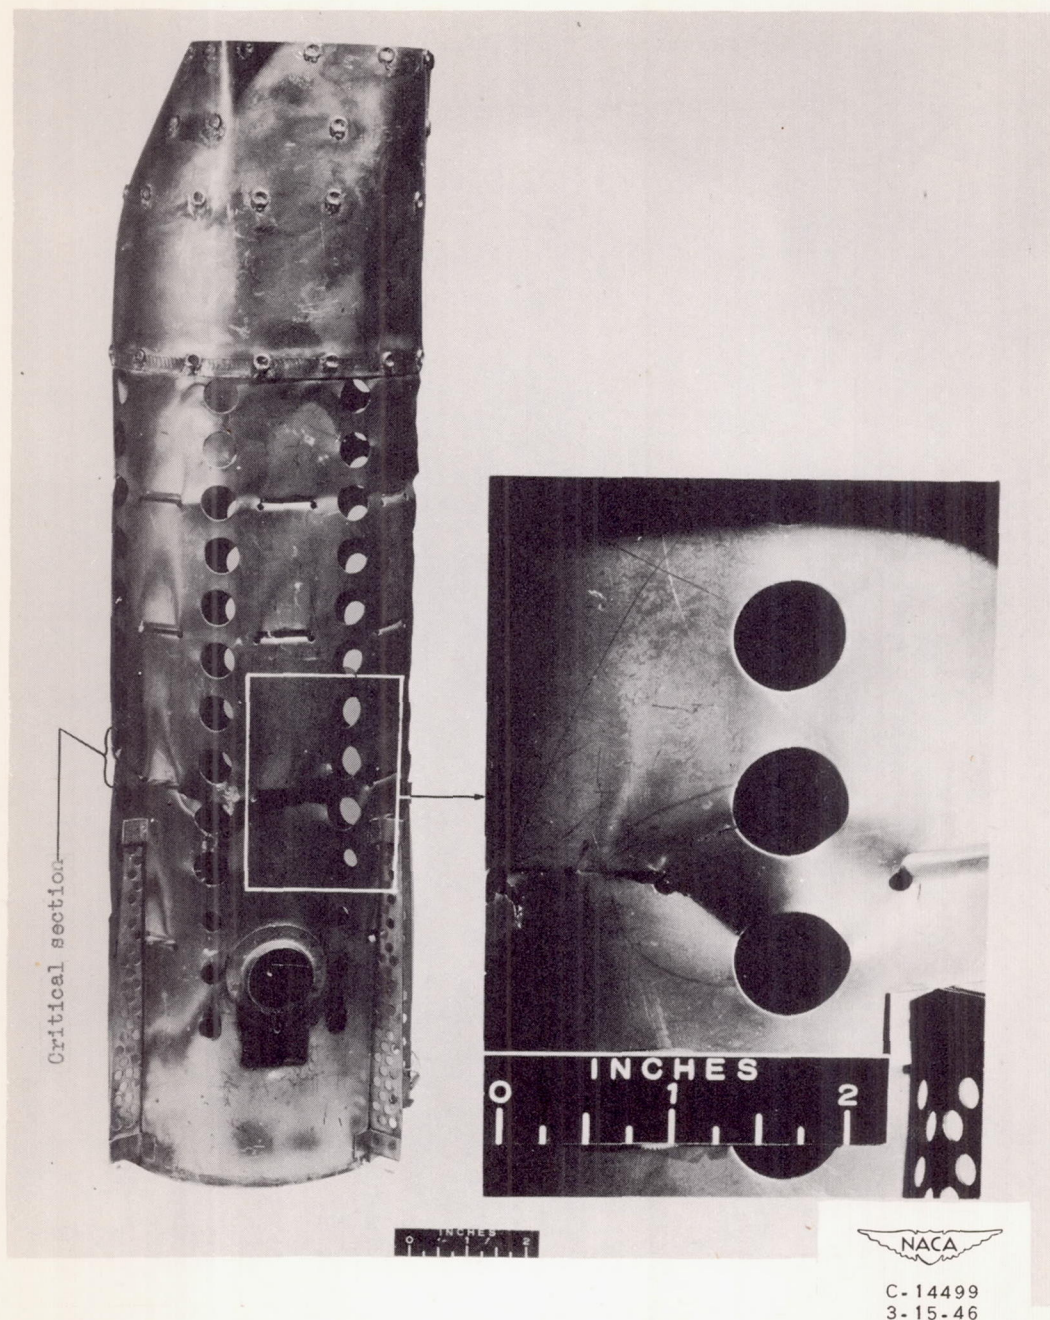
A liner failure typical of 14 liners removed from a service engine after 36 hours and 10 minutes operation is shown in figure 17. The severe warping and fractures are clearly shown in the photograph. The most severe warping and fractures occur in the belt of louvers marked "critical section."

1. Temperature variations from point to point on the burner liner were extreme. The measured local temperature gradients were as large as 700° F per inch. The warping and fractures, occurring principally between the louvers and adjoining intake-air holes, are attributed to these extreme temperature gradients.
2. The maximum burner-liner indicated temperature (1590° F) occurred at a point about  $9\frac{1}{2}$  inches from the inlet end of the liner.

This thermocouple was one of the belt nearest the critical section, which is located about 8 inches downstream of the burner-liner inlet. Most of the buckling and fracturing of burner liners investigated occurred in the critical section.

Figure 17. - Typical burner-liner failure. Total operating time, 36 hours and 10 minutes.
